2012 Regulatory Information Conference – W19

Insights & lessons-learned from “Inadvertent Containment Spray during the Commissioning Stage”

March 2012

Korea Institute of Nuclear Safety

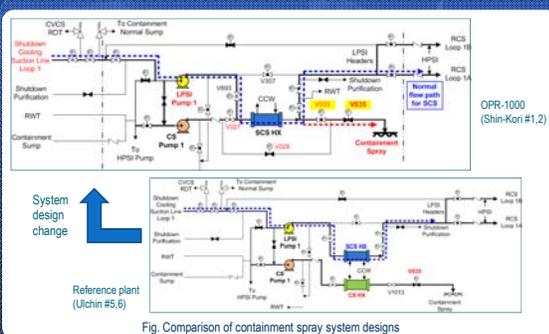
Design Changes

- Inadequate test procedure not reflecting system design change
 - the shutdown heat exchanger outlet isolation valve (CS-V033), which should be closed during the heat-up operation, had been opened
- Inappropriate organization attitude toward plant commissioning
 - delayed organization for commissioning operation
 - insufficient training for the operating staff, resulting in the poor plant familiarization
