RIC 2013 Stress Corrosion Cracking Including Control Rod Drive Mechanisms

David Alley
EPNB/DE/NRR
13 March 2013

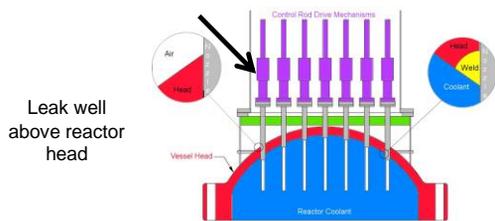
- Rack and Pinion CRDM Mechanism
- Only two plants built this way
- 316 stainless
- Crack at internal (non pressure boundary) weld

- 9 Cracks
 - 1 through wall
 - All axial
 - In two groups
 - 1 rub mark

- Resolution
 - Housing Replaced
 - 8 others inspected
 - No defects
 - NRC reviewing Plant root cause evaluation
 - Additional inspections planned in 2013 and in the future
