BROWNS FERRY NUCLEAR PLANT FIRE

HEARINGS

JOINT COMMITTEE ON ATOMIC ENERGY
CONGRESS OF THE UNITED STATES

SEPTEMBER 16, 1975

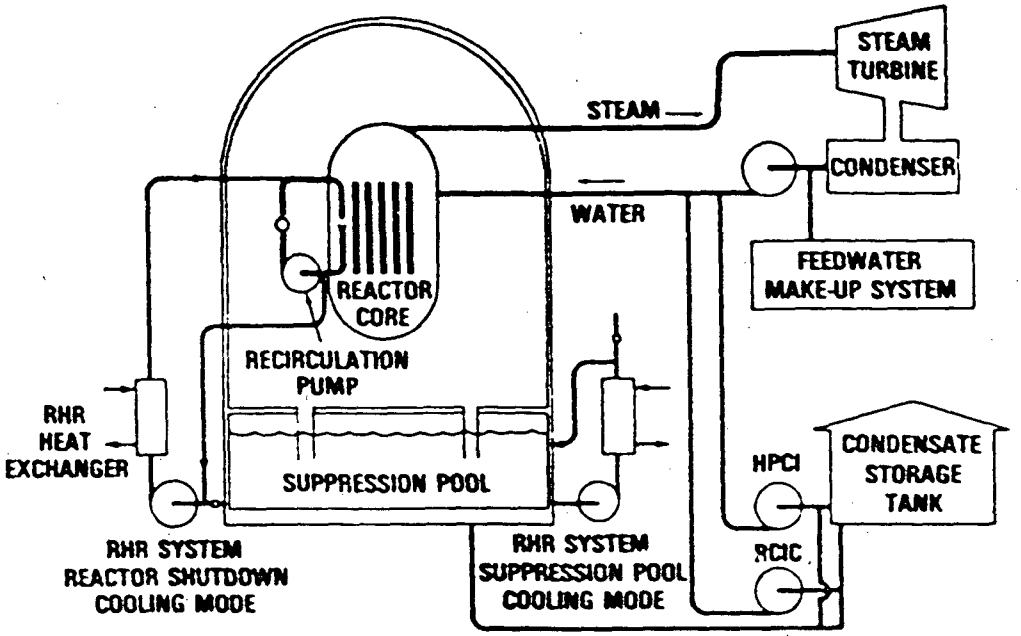
FIGURE 1.—Systems available for normal cooldown.

In light of this situation, the operators decided to depressurize the primary coolant system by opening relief valves. The system normally used for shutdown cooling are shown on Figure 1. As noted in the detailed staff analysis in Attachment I, alternate methods for depressurizing the primary system were available and there also were available manual methods for supplying cooling water at high pressure.

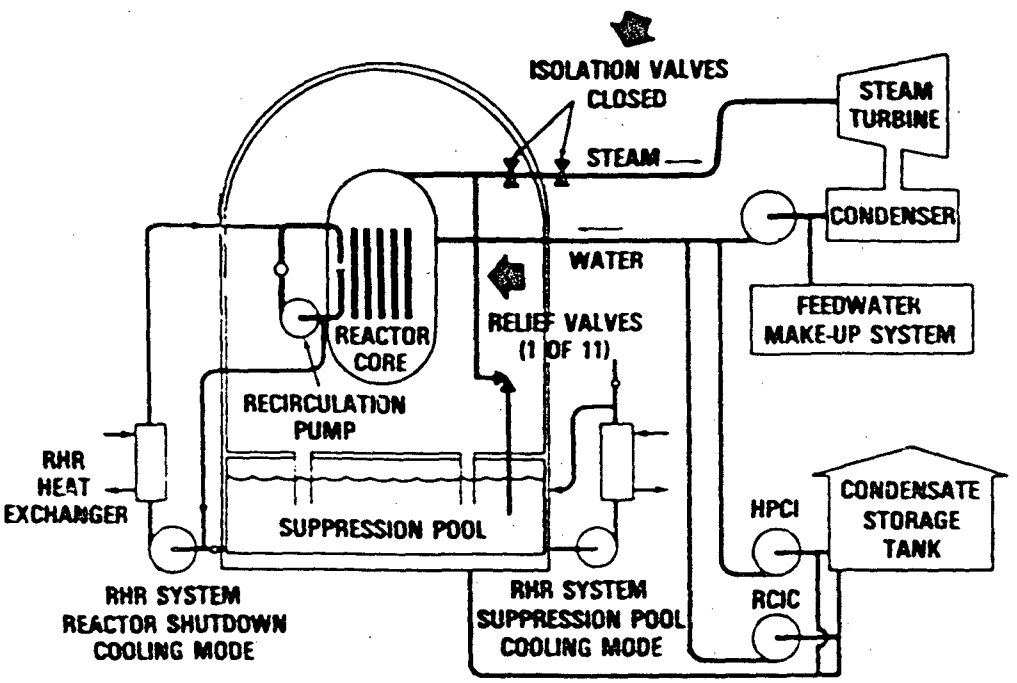
FIGURE 2.—Steam path to suppression pool via relief valves.

Following their selected course, the operators depressurized the reactor by discharging steam from the reactor to the suppression pool through the four relief valves that could be operated from the control room (Figure 2). This discharge heated up the water in the suppression pool as intended. Because of the large volume of water in the pool, about 12 hours of such discharge could be accommodated before the pool water would boil, even though the cooling system for the suppression pool was not available at the time. Even if the pool water had boiled, the resultant steam could have been vented to the atmosphere. Once the reactor pressure was reduced, a low pressure condensate pump was used in conjunction with a condensate booster pump to provide an adequate source of water for cooling the fuel. A total of three of these condensate booster pumps and three condensate pumps were available to the operator at this time. Any of the condensate pumps would have been capable of supplying more than enough water to keep the core covered (Figure 3). Also, the Unit 1 control rod drive pump supplied some water to the reactor throughout reactor cooldown.

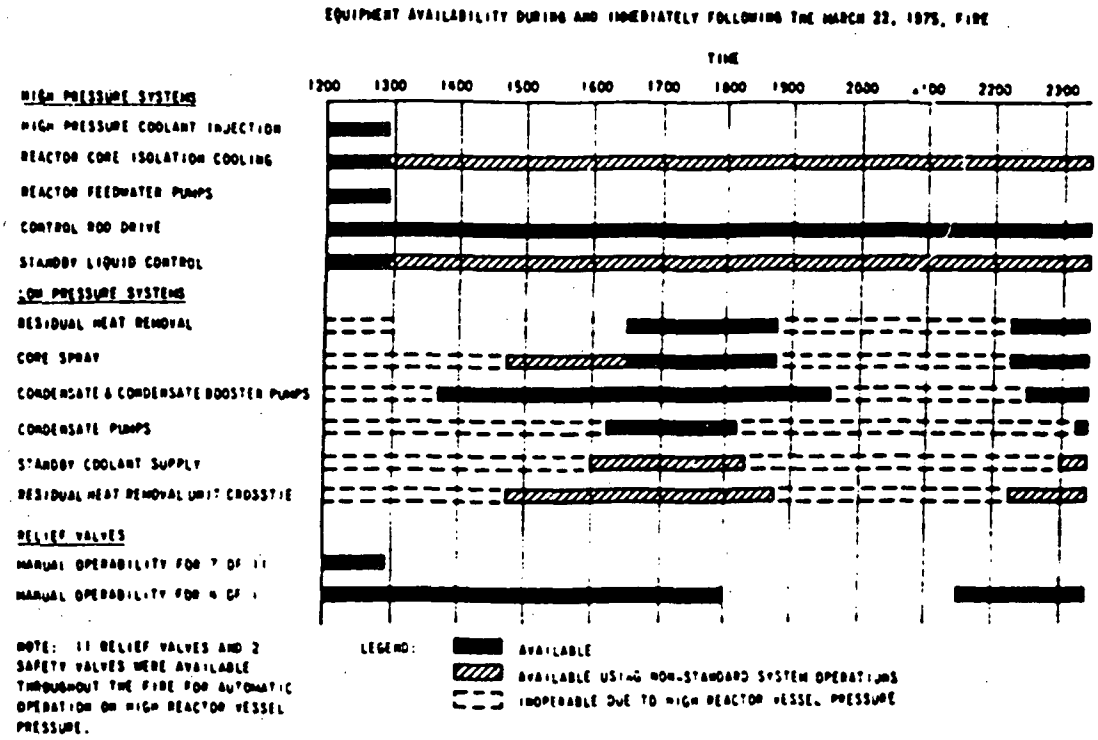
FIGURE 4.—Browns Ferry Nuclear Plant Unit I.

The availability of the core cooling systems is summarized in Figure 4 and clearly demonstrates that there was indeed no "near nuclear disaster."

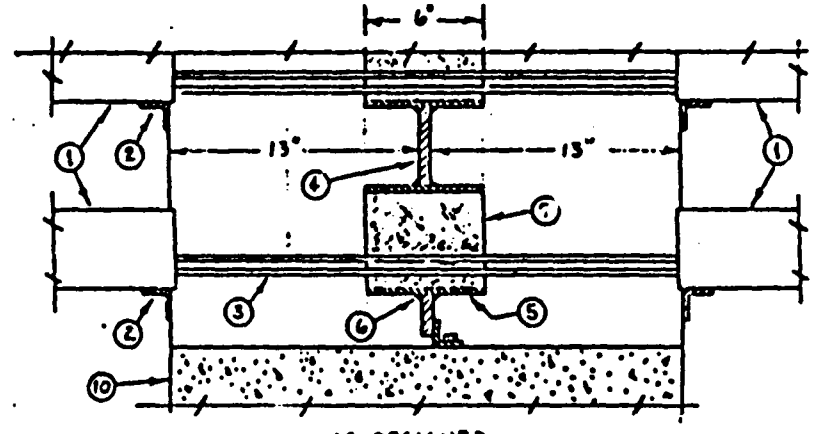
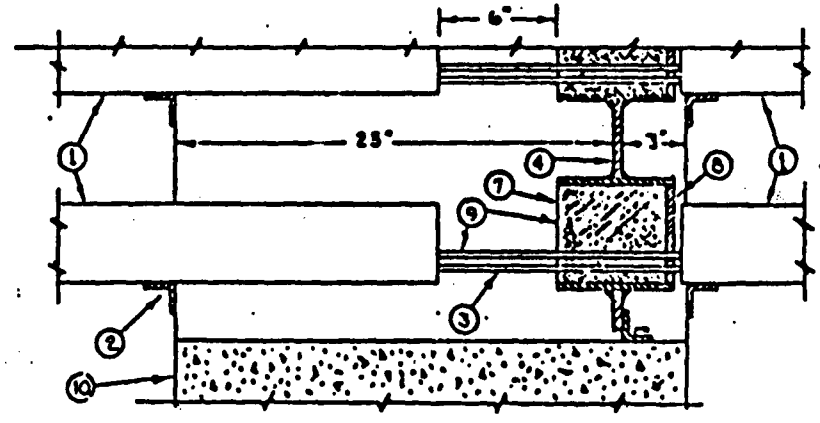
AS DESIGNED

AS CONSTRUCTED

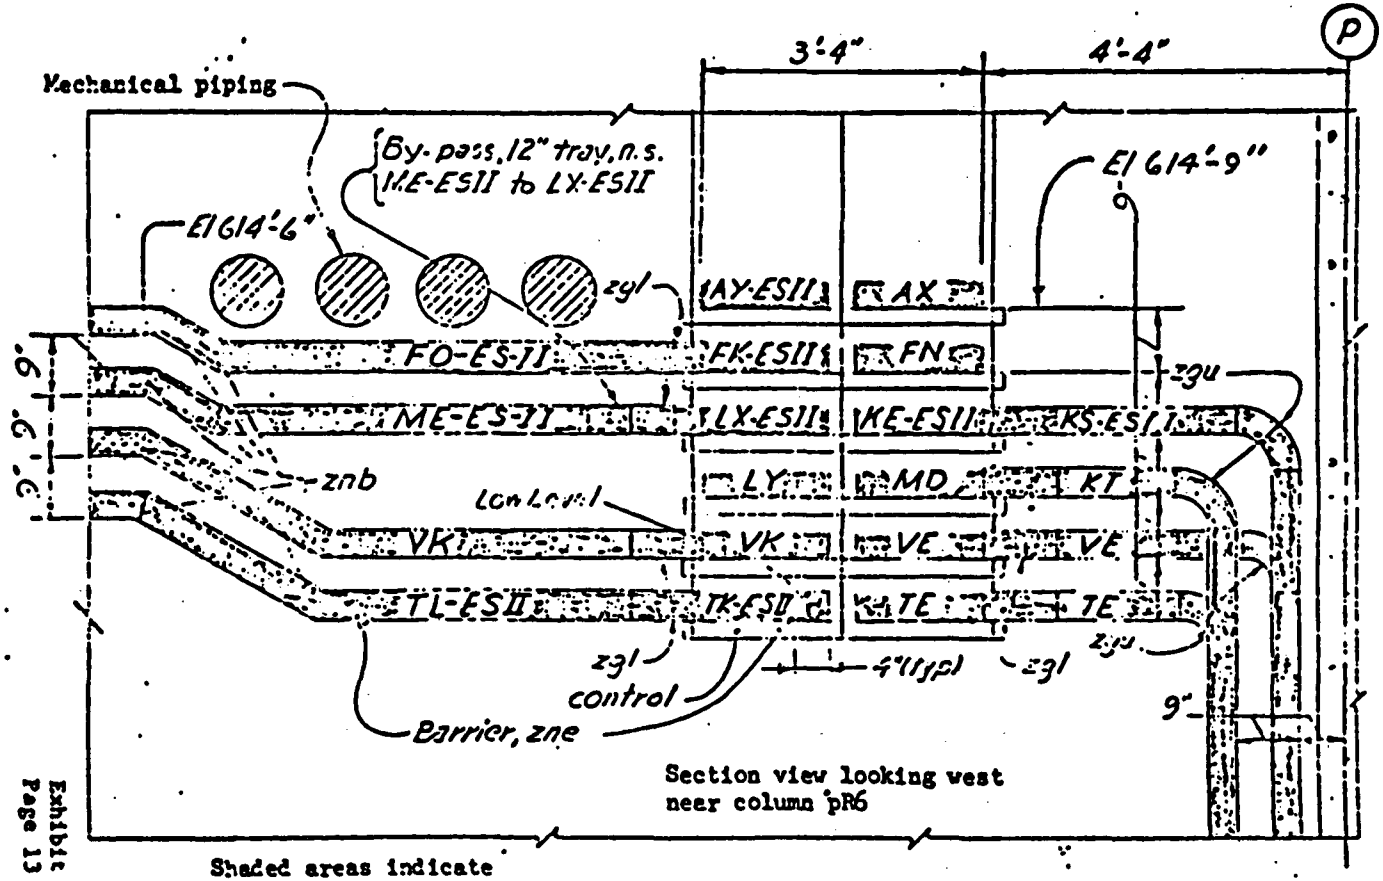
Section view looking west
near column pR6

Shaded areas indicate
damaged trays

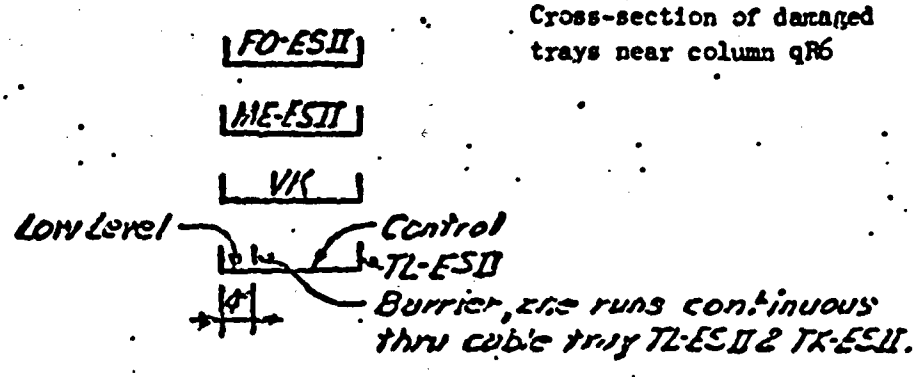
SECTION B6-B6
Scale: ½"=1'-0"

Cross-section of damaged trays near column qR6
