RIC 2012 Spent Fuel Pool Lessons Learned

Richard A. Laura
Japan Lessons Learned Project
Directorate, NRR
March 14, 2012

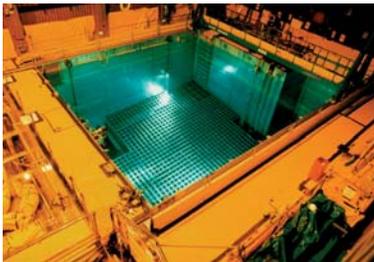
Spent Fuel Pool Construction

- Robust construction features:
 - Thick reinforced concrete walls and floor slabs lined with stainless steel plate
 - Walls are typically several feet thick
 - Floor slabs are typically several feet thick
 - Typical dimensions are 40 feet long, 35 feet wide and 40 feet deep
