**The NRC Staff Perspective on Recent Operating Experience**

Stephen Cumblidge  
2014 RIC  
March 11, 2014

**Outline**

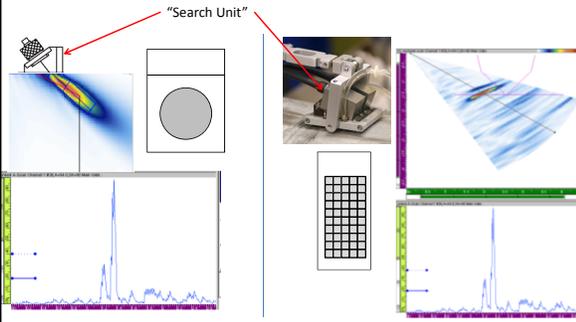
The image shows a "Search Unit" with a probe and a control panel. It includes a B-scan image showing a curved defect, a C-scan image showing a rectangular defect, and two A-scan waveforms showing amplitude versus time. The probe is shown in a manual testing setup on a metal surface.

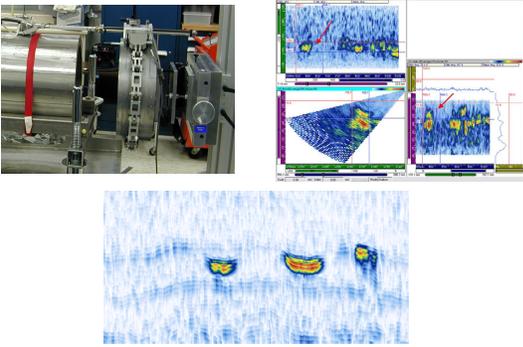
**Encoded Scanning**

The image shows an encoded scanning machine with a red safety strap. The software output includes a B-scan image with a curved defect, a C-scan image with a rectangular defect, and a large A-scan waveform showing multiple peaks.

An encoded examination would have had a much better chance of finding the cracks

The crack was recorded in the encoded data  
The inspection procedure was effective
